**PRELIMINARY ASSESSMENT/  
VISUAL SITE INSPECTION**

**GENERAL MOTORS CORPORATION -  
NORTHERN AMERICAN TRUCK PLATFORMS  
(FORMERLY GENERAL MOTORS CORPORATION -  
TRUCK AND BUS GROUP)  
DETROIT, MICHIGAN  
MID 076 380 583**

**FINAL REPORT**

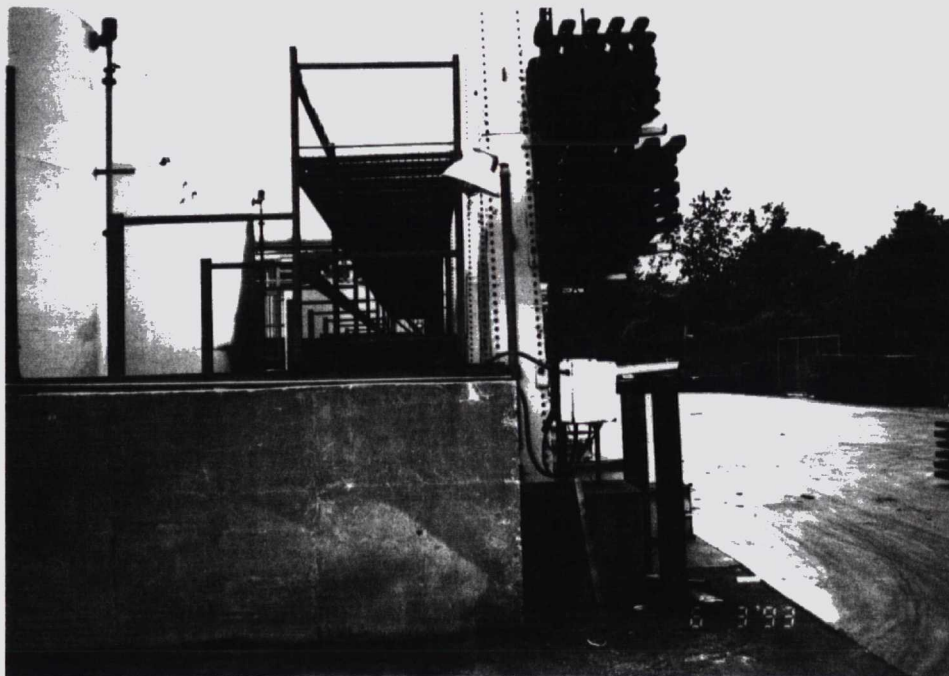
Photograph No. 1

**Observations:** The unit contained no hazardous waste during the VSI. PRC noted no evidence of release (see Photograph No. 1).

Description: Former East CSA with the erected metal racks inside the 3-foot concrete berm and next to the Product Diesel Fuel ASTs (AOC 1)

**Recommendations:**                      PRC recommends no further action for this SWMU at this time.

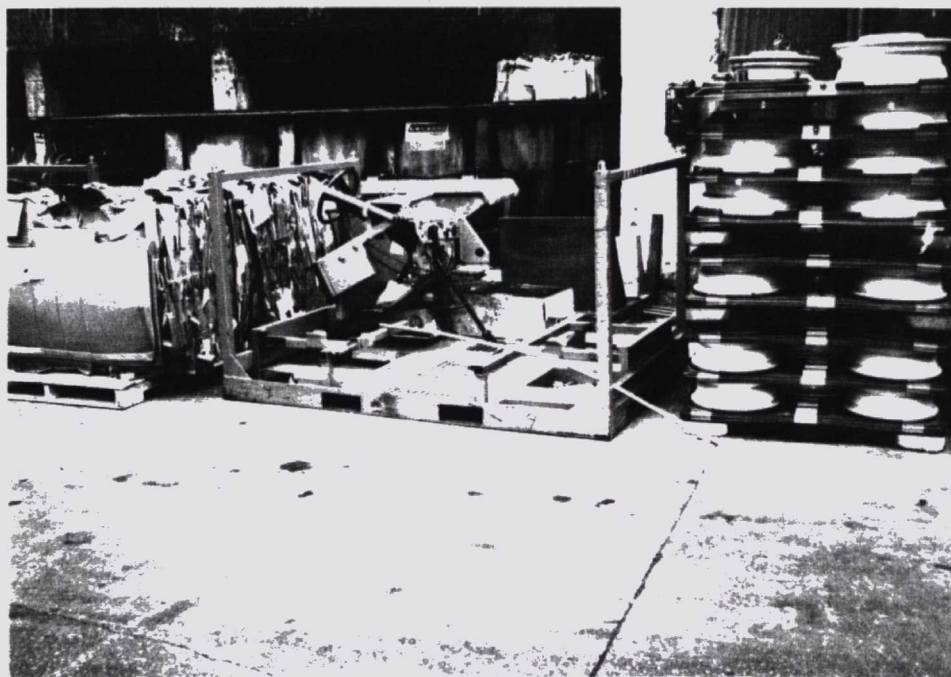
Photograph No. 2

**Observations:** The unit contained no hazardous waste during the VSI. PRC noted no evidence of release (see Photograph No. 2).

Description: Former West Gondola Storage Pad in front of the facility's equipment

**Recommendations:** PRC recommends no further action for this SWMU at this time.

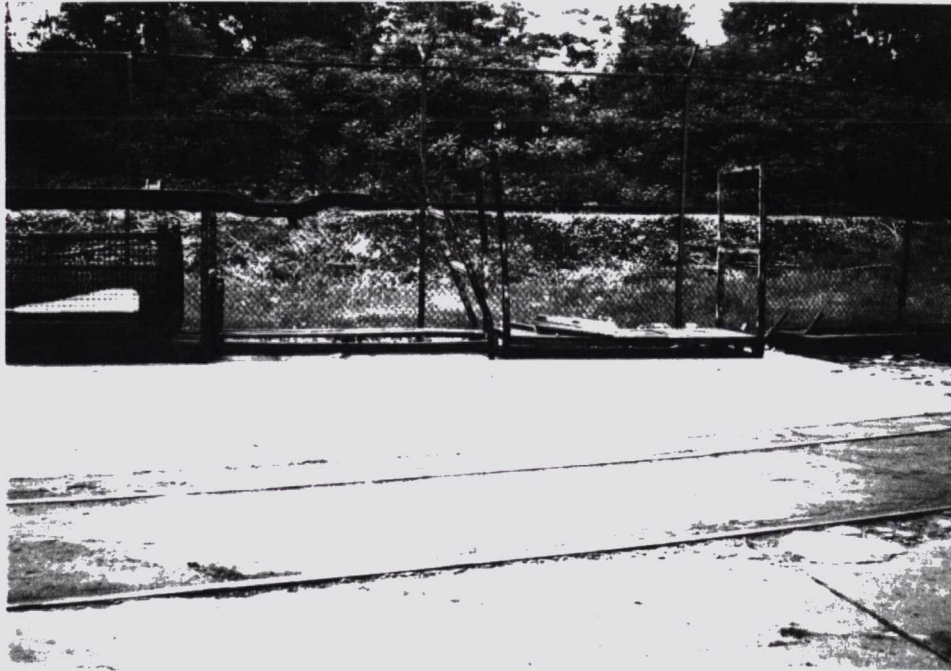
Photograph No. 3

**Observations:** The unit contained no hazardous waste during the VSI. PRC noted no evidence of release (see Photograph No. 3).

**Recommendations:** PRC recommends no further action for this SWMU at this time.

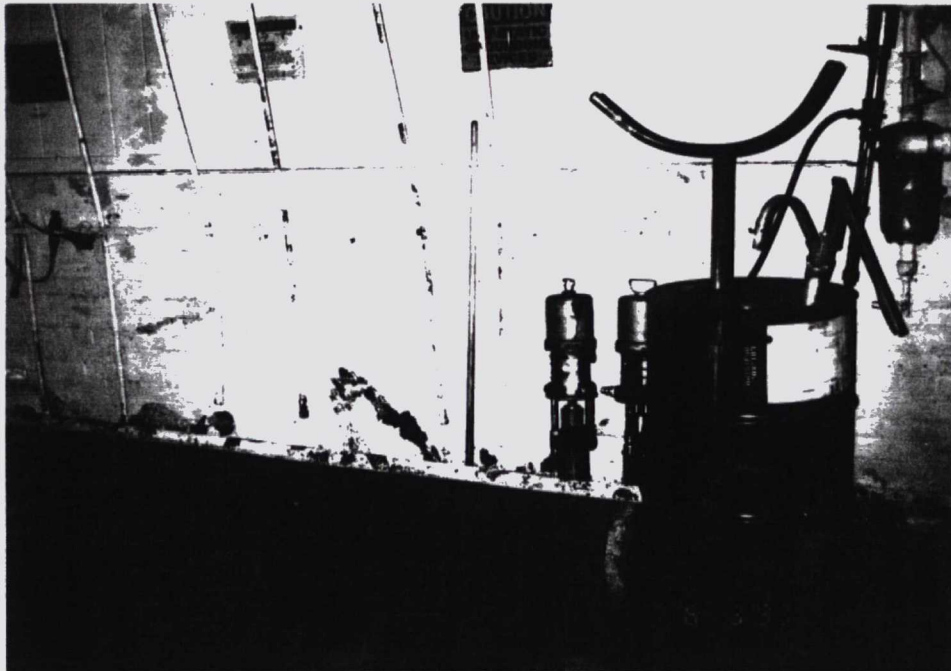
Photograph No. 4

**Observations:** The unit contained no hazardous waste during the VSI. The hazardous waste area in the Paint Mix Room contained one 55-gallon drum of product material. The concrete floor was wet from water that leaked into the room through holes in the bottom of the outside wall; however, PRC noted no evidence of a release (see Photograph No. 4). The hazardous waste area near the paint booth contained truck chassis. No cracks in the concrete floor or visible evidence of spills were observed (see Photograph No. 5).

**Recommendations:** PRC recommends no further action for this SWMU at this time.

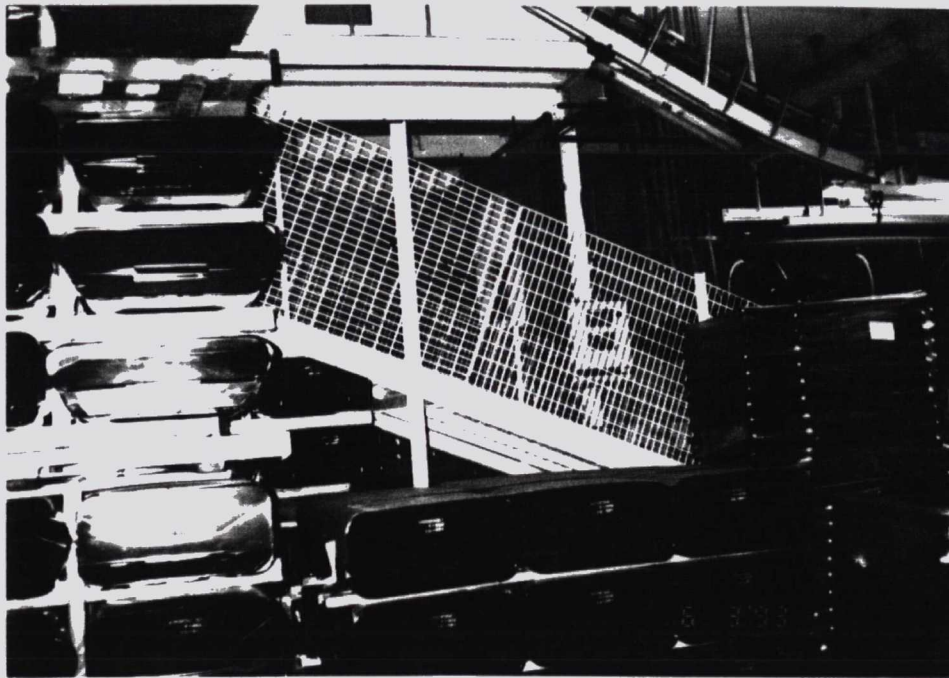
Photograph No. 5

**Observations:** The unit contained no hazardous waste during the VSI. The unit contained truck chassis. No cracks in the concrete floor or visible evidence of spills were observed (see Photograph No. 5).

Description: Former Spent Solvent SAAs and Former CAA near the paint booth; this area currently contains truck chassis

PRC recommends no further action for this SWMU at this time.

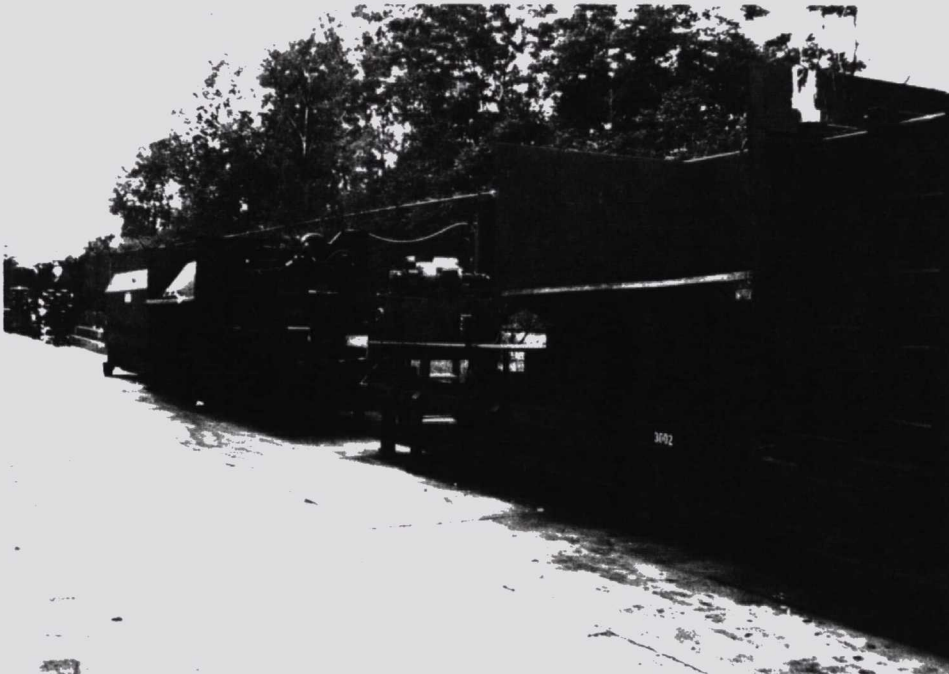
Photograph No. 6

Description: Trash compactor with 20-cubic-yard container on a concrete pad that had cracks which were sealed

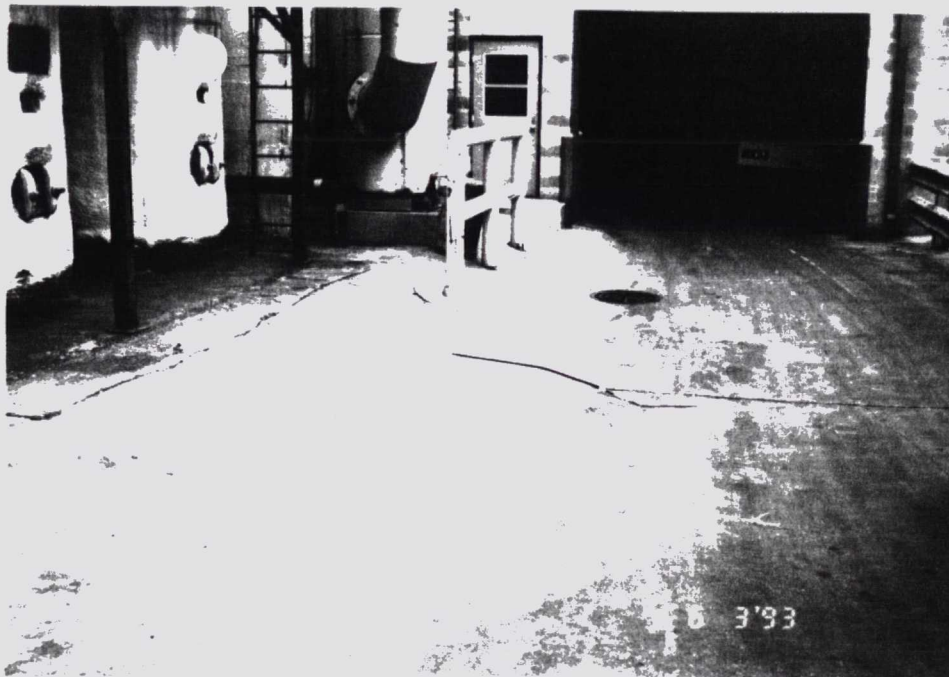
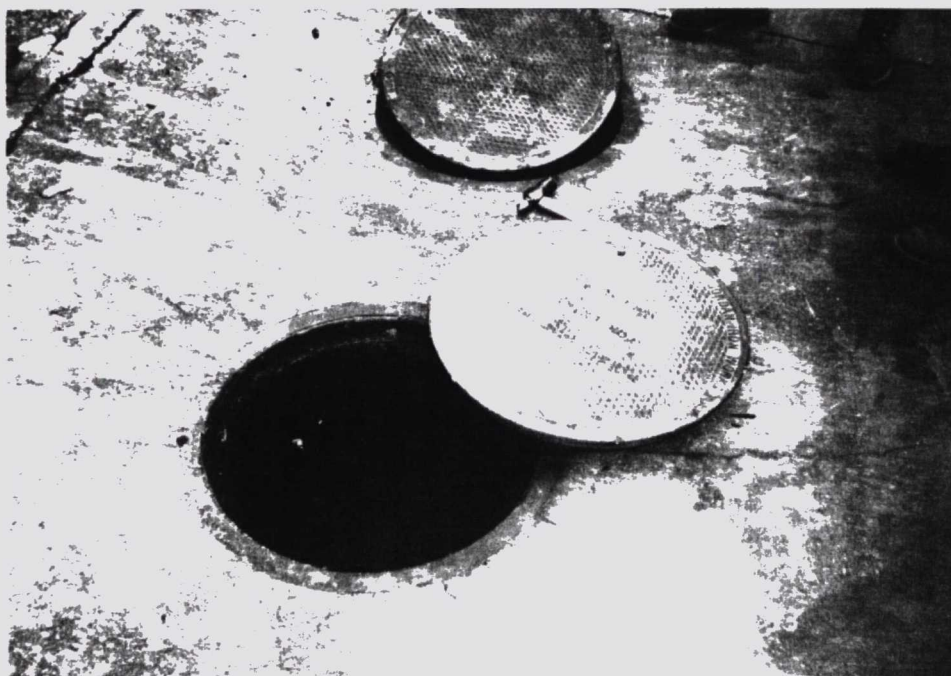
Photograph No. 7

Michigan, for dewatering and recovery of lime. During the VSI, PRC noted a milky white sheen on the water in the storm water manhole near the Lime Wastewater Holding Tank (SWMU 7). Two of the three lids for the Lime Wastewater Holding Tank were removed and water in the tank had the same milky white sheen. Facility representatives did not know the size of the Lime Wastewater Holding Tank (SWMU 7); however, the holding tank is about 20 years old.

tank's construction material. PRC noted water with a milky white sheen in the unit and in the storm water manhole near the unit.

The potential for release to on-site soils is low to moderate because the tank is old, constructed of unknown material, and the water may contain hazardous constituents. The potential for release to groundwater, surface water, and air is low.

**Recommendations:** PRC recommends that the facility identify the source of the milky white sheen on the water surface. PRC also recommends sealing the underground pipes, and emptying and properly disposing of the contents in the unit.

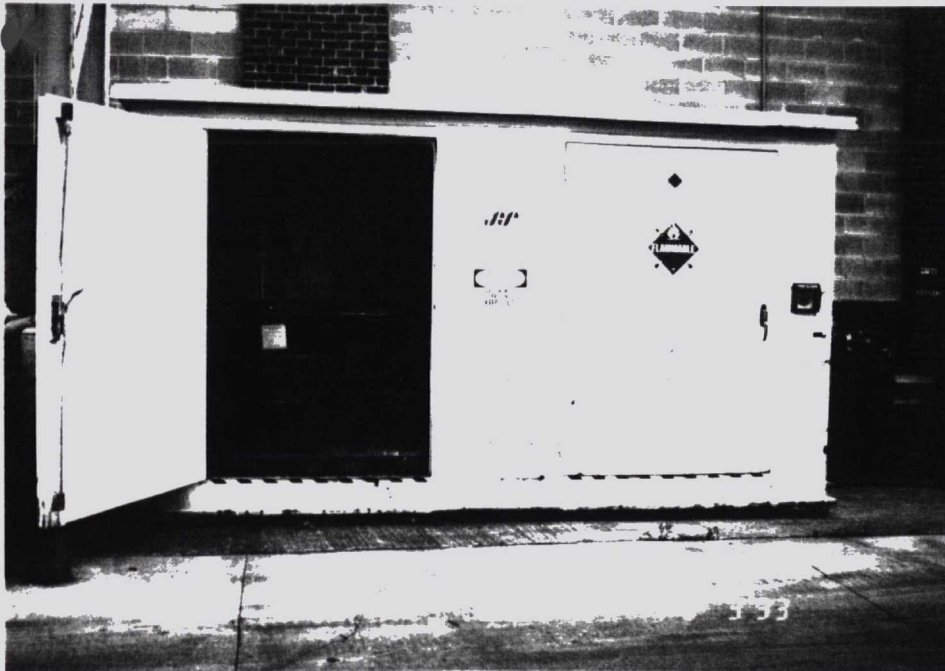
Photograph No. 9

**Observations:** The unit contained two 55-gallon steel drums of spent toluene, two 55-gallon steel drums of spent diesel fuel (D001), and six 55-gallon steel drums of product material. During the VSI, the 55-gallon drums were in good condition and were stored closed on pallets. PRC noted no evidence of release (see Photograph No. 9).

**Conclusions:** This unit is located outdoors on a concrete pad next to the Assembly Building. During the VSI, the 55-gallon drums were in good condition and stored closed.

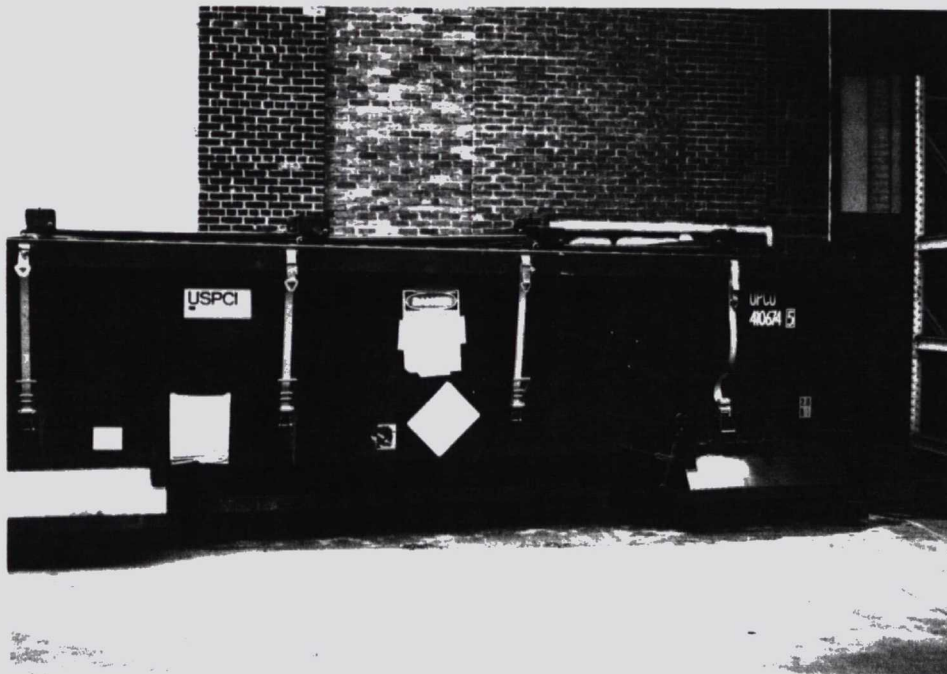
Photograph No. 10

**Observations:** The unit contained about 20 cubic yards of asbestos during the VSI. The unit was covered and closed. PRC noted no evidence of release (see Photograph 10).

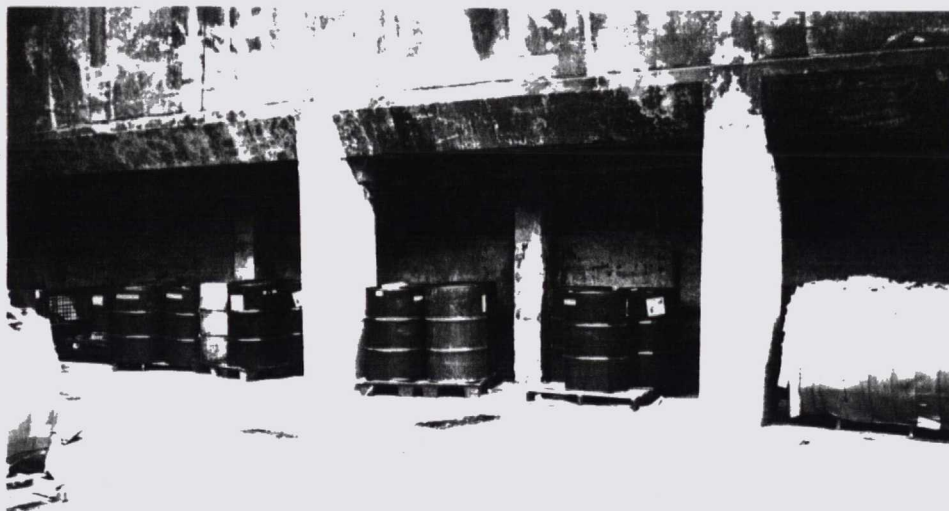
Photograph No. 11

**Observations:** During the VSI, the unit contained 15 55-gallon steel drums of caustic wastewater. PRC noted minor waste stains near the unit; however, PRC noted no evidence of release from the unit to environmental media. During the VSI, the 55-gallon steel drums were on pallets in good condition and stored closed (see Photograph No. 11).

Description: Nonhazardous CSA located a concrete pad that had 55-gallon steel drums of caustic wastewater on pallets

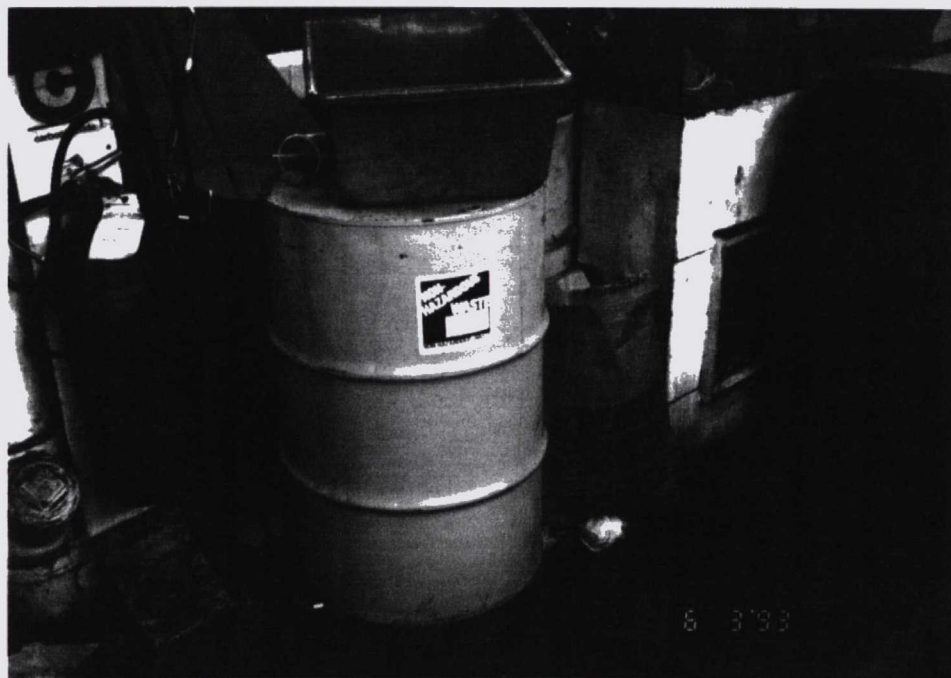
Photograph No. 12

**Observations:** During the VSI, one area contained about 30 gallons of used oil. The 55-gallon steel drums were also in good condition and stored closed. PRC noted oil stains on the concrete floor surrounding the unit (see Photograph No. 12).

Description: Typical used oil accumulation area with oil stains on the concrete floor surrounding the unit

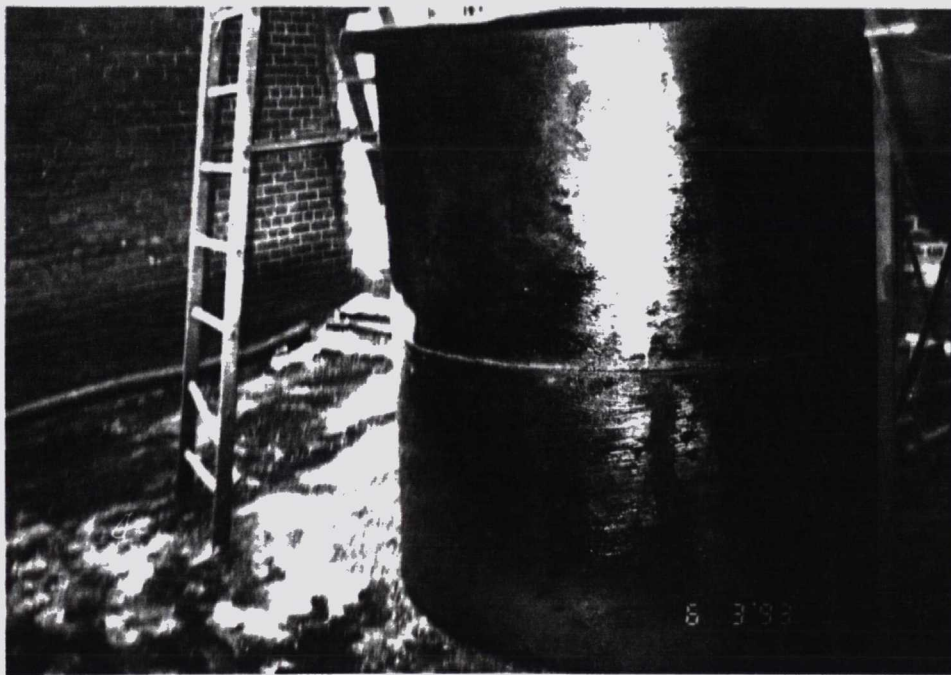
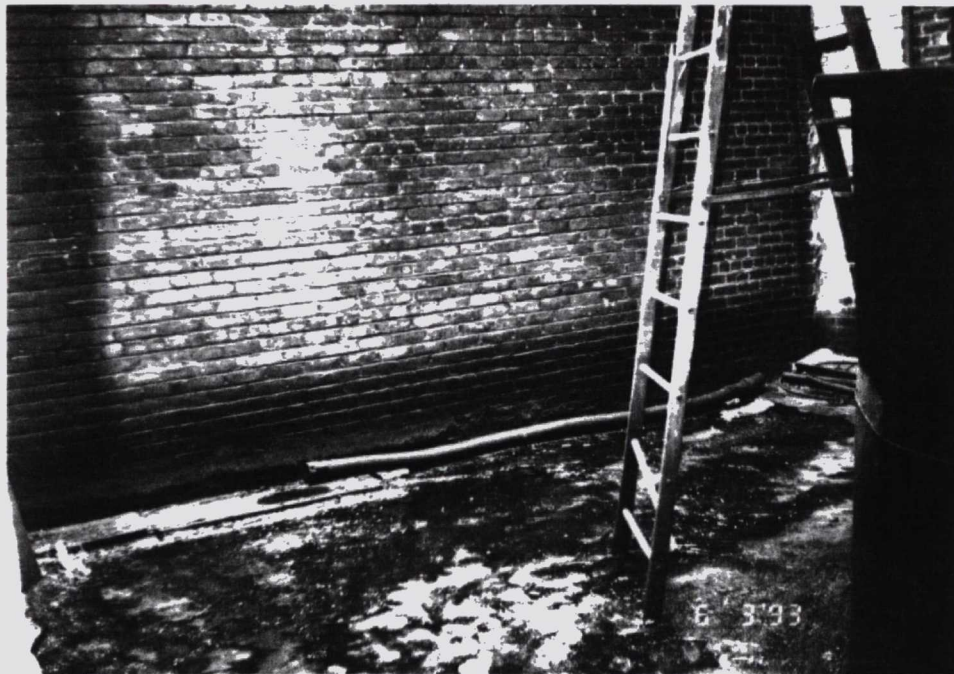
Photograph No. 13

**Observations:** The unit contained about 200 gallons of nonhazardous used oil during the VSI. PRC noted puddles of used oil on the steel roof surrounding the unit. The pipes leading inside the Assembly Building were sealed (see Photographs No. 13 and 14).

Description: The 800-gallon used oil ASTs; note used oil on the steel roof surrounding the unit

Description: The 800-gallon used oil AST; note used oil on the steel roof surrounding the unit

PRC recommends the facility identify the source of the milky white sheen, seal the underground pipes, and properly dispose of the contents in the Lime Wastewater Holding Tank (SWMU 7). Also, the facility should cover the 800-Gallon Used Oil AST (SWMU 12) and practice better waste management techniques. PRC recommends that the facility conduct soil sampling for organic constituents and total petroleum hydrocarbons (TPH) at the Product Diesel Fuel ASTs (AOC 1) to determine if releases have occurred.
